Navajo Abandoned Uranium Mine

Site Screen Report

Julius Chee No. 3 AUM Site

Navajo AUM Western Region

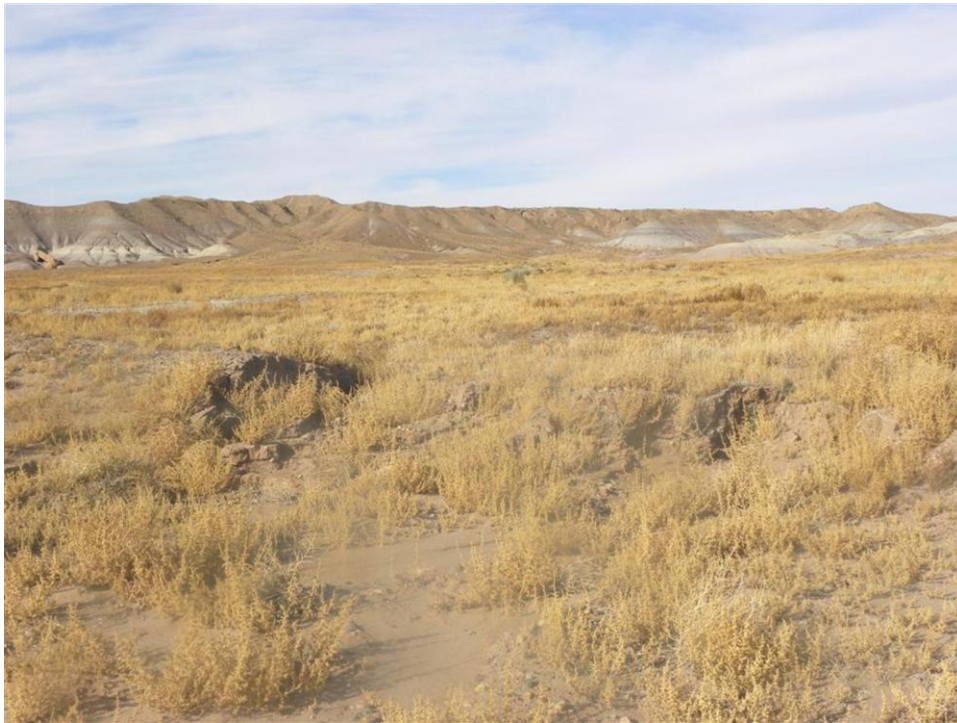
Photo 2. Julius Chee No. 3 mine site, berm area

Series of reclamation berms, over area identified on old topo maps as "tailings", berms cover the corner area between sites 159, 549, 550, and 1041, breached in the southwest
